Priority School Building Programme

Mill Green School Geo-environmental Desk Study

January 2013
Education Funding Agency

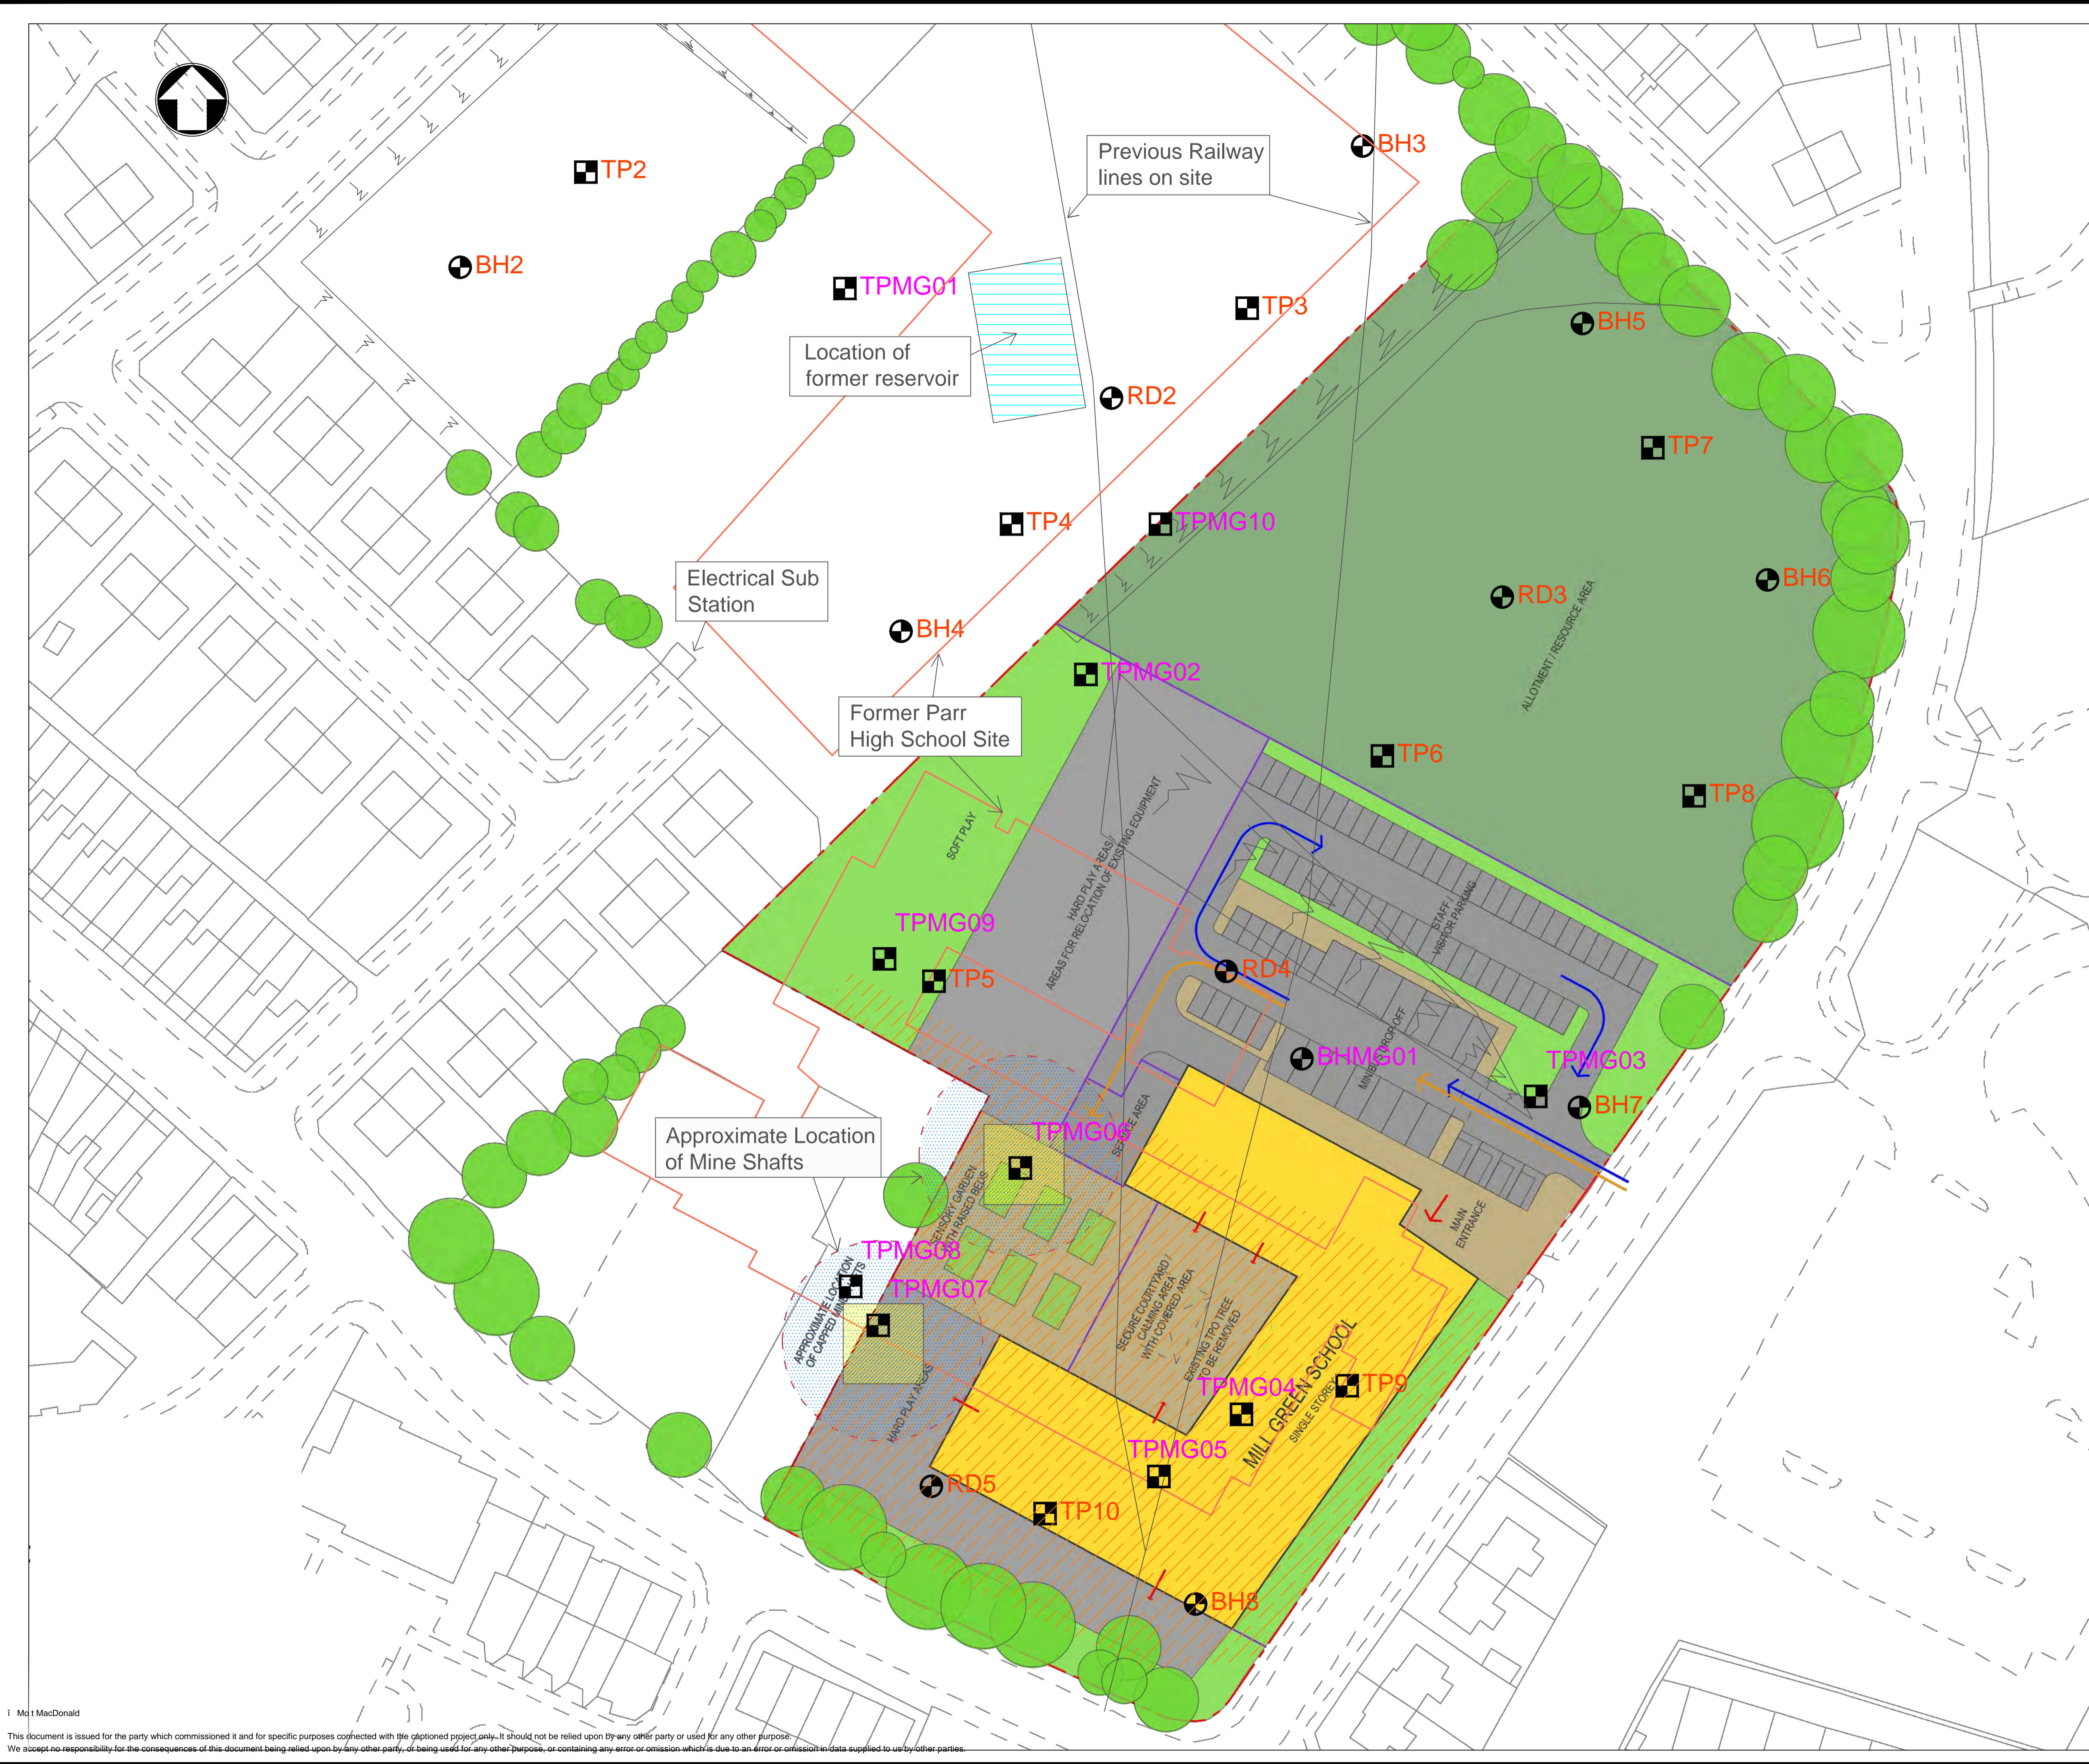
Appendix E. Geo-Environmental Risk Plan

- BH2, TP4: Approximate location of 2003 RTD Exploratory Holes
- BHMG01, TPMG01: Approximate location of 2008 FES Exploratory Holes
- 2008 FES Geophysical Survey Area refer to report for area of anomalies
- Approximate location of Coal Shafts
- Former footprint of Parr High School. Potential for encountering former buried foundations
- Existing Slope
- Footprint of proposed Mill Green School
- Location of Former Reservoir on site
- Approximate location of probe drilling for Mine Shaft undertaken by RTD (2003)
